CLEANING & RESTORATION

2014 PHOENIX AWARD FOR INNOVATION IN RESTORATION

Innovative Drying of a Water-Damaged Gym Floor Slashes Time and Cost

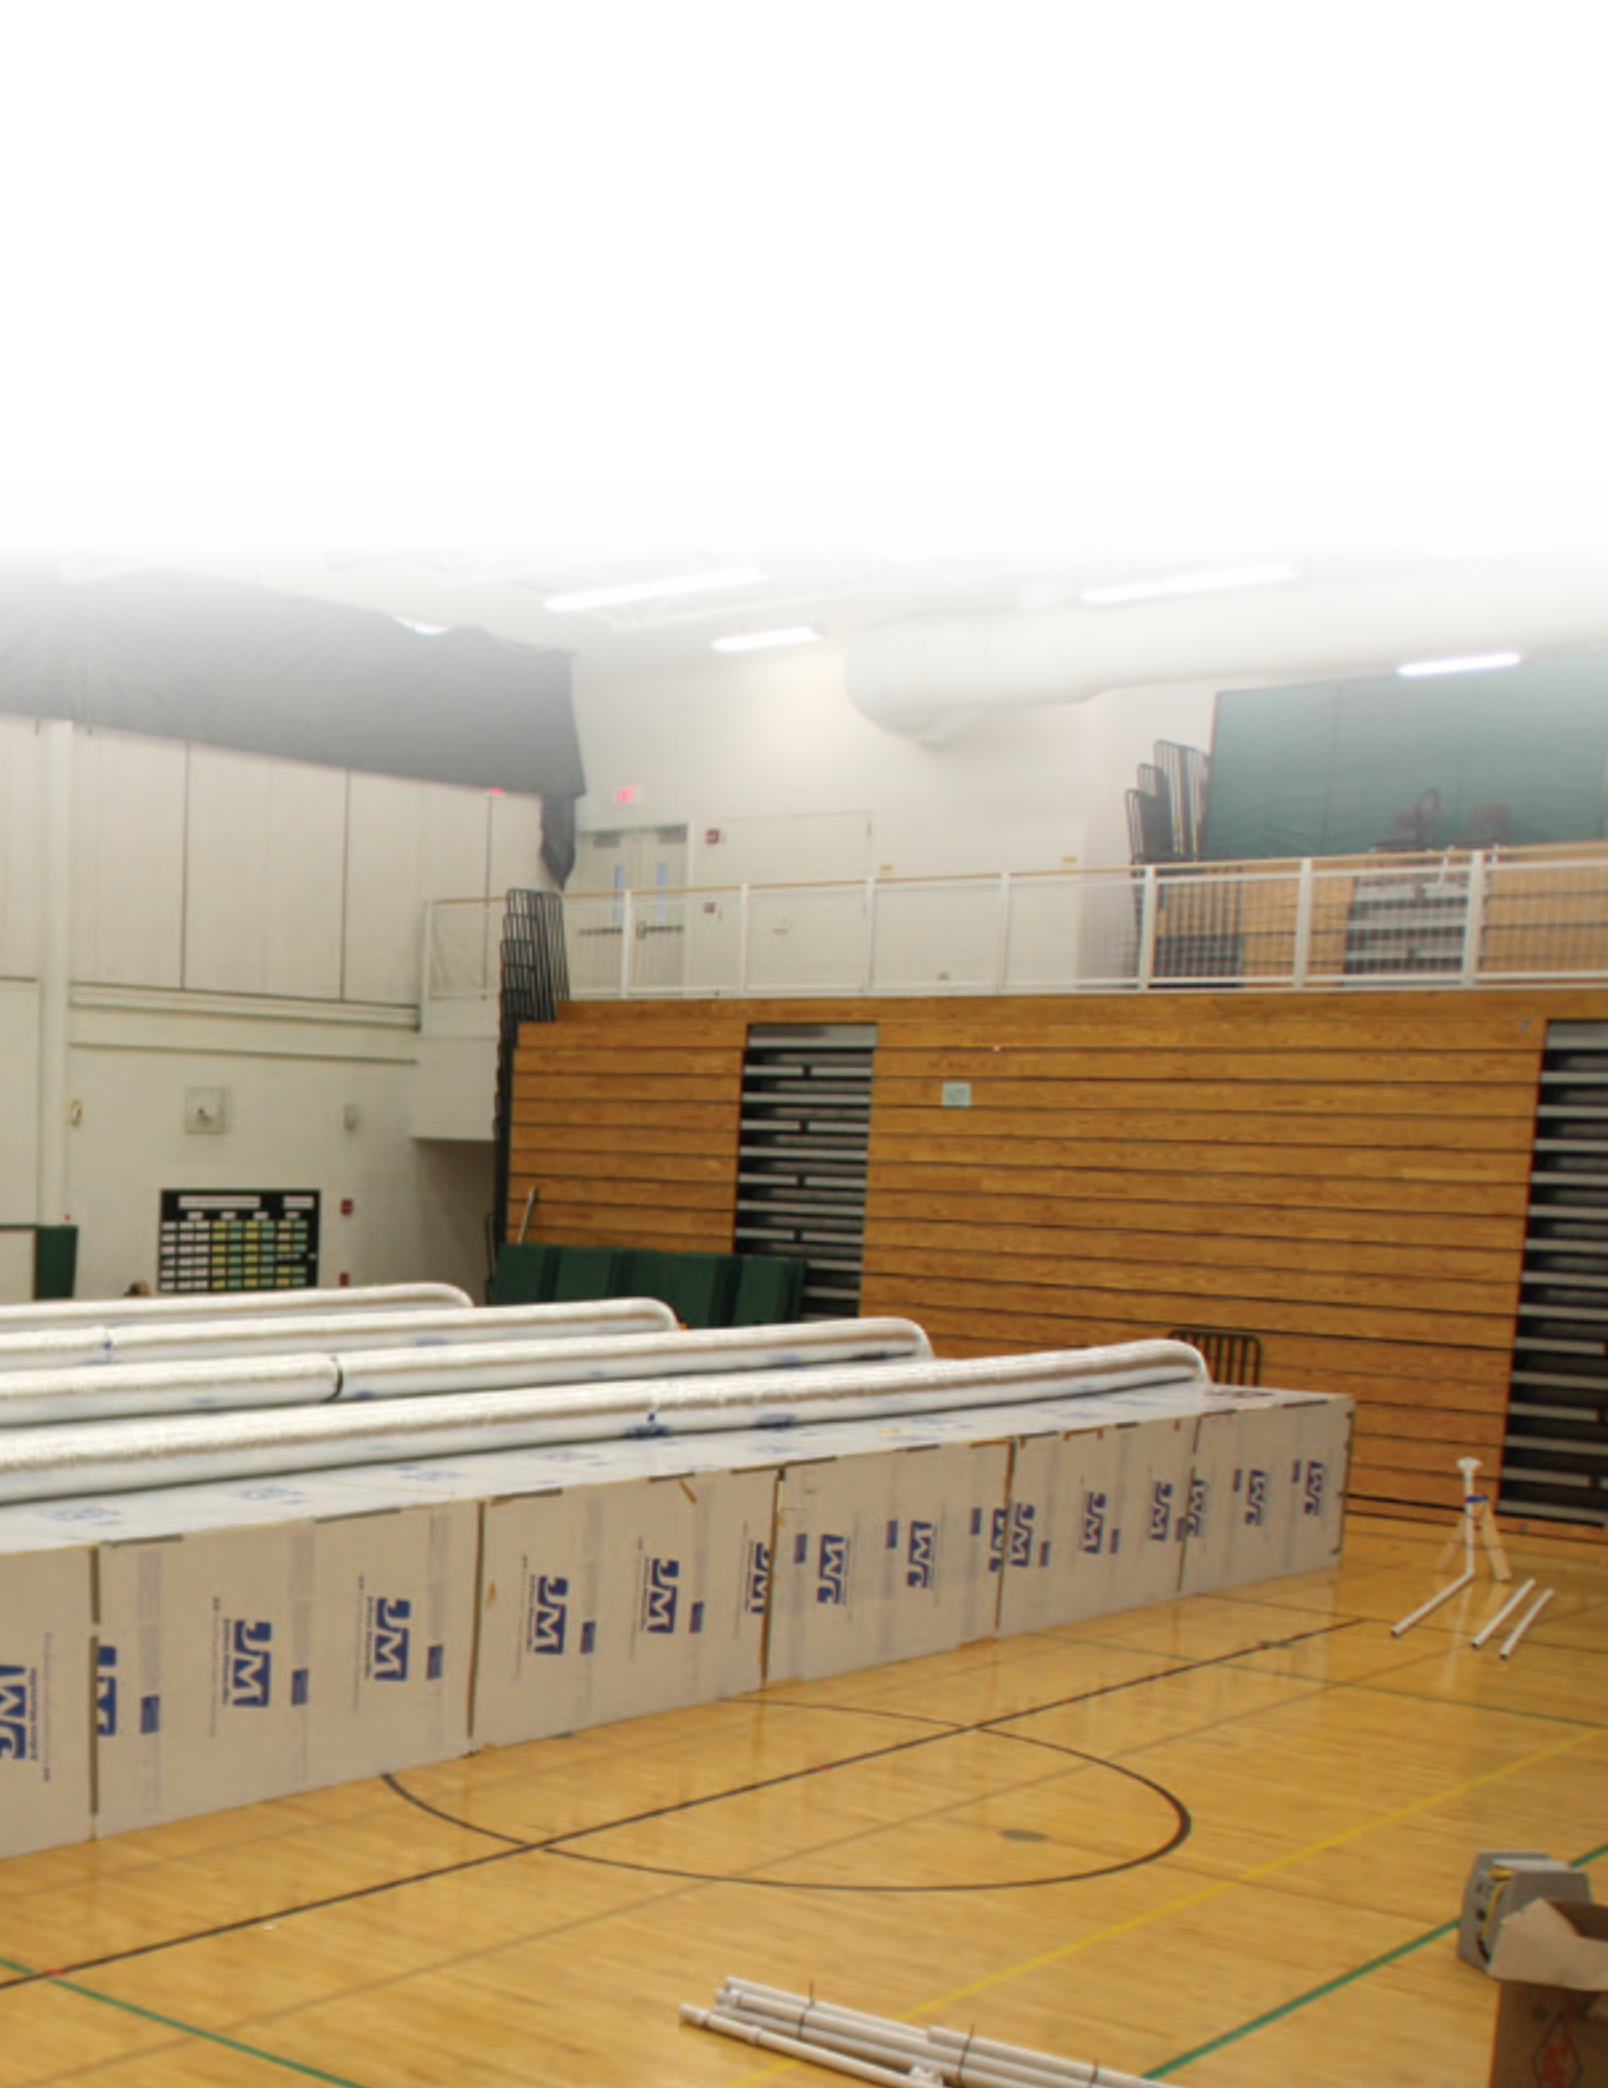
The set-up process required a highly coordinated effort by the entire response crew. Creating the temperature-control containment was a laborious undertaking. The process used all the restorative drying factors together, all under total technical control. Switchable lighting was added for additional safety in the confined space and to facilitate the meter-reading process.

It took the team only five days to restore the floor’s moisture content to normal levels. This ended up being one of the fastest floor recoveries the ACR team had undertaken. Using this type of containment was critical to introducing temperature control and managing the pieces to accelerate the drying time. Tenting would have taken two to three times longer to dry the floor, but still would have been faster than a full replacement. The surface boards as well as the floor were flat and ready to use without any resealing or restriping required.

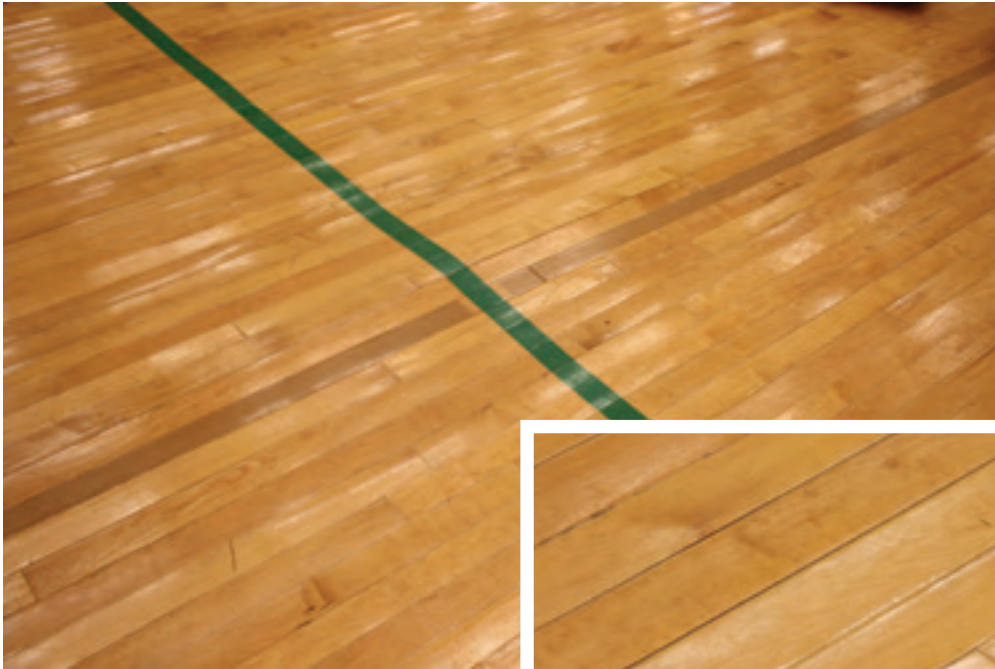
(Above) A plumbing-related failure released water down the gymnasium wall, and under the center of the affected half of the gym. This water loss was more highly concentrated and directional, causing a higher range of damage into a smaller area.

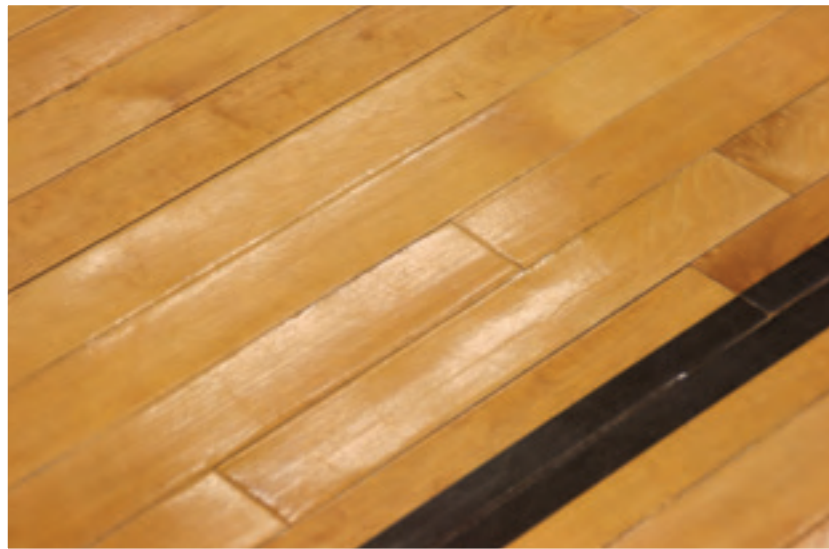
(Right) The distortion of the wood was serious. Both the width and the length of the boards were swollen.

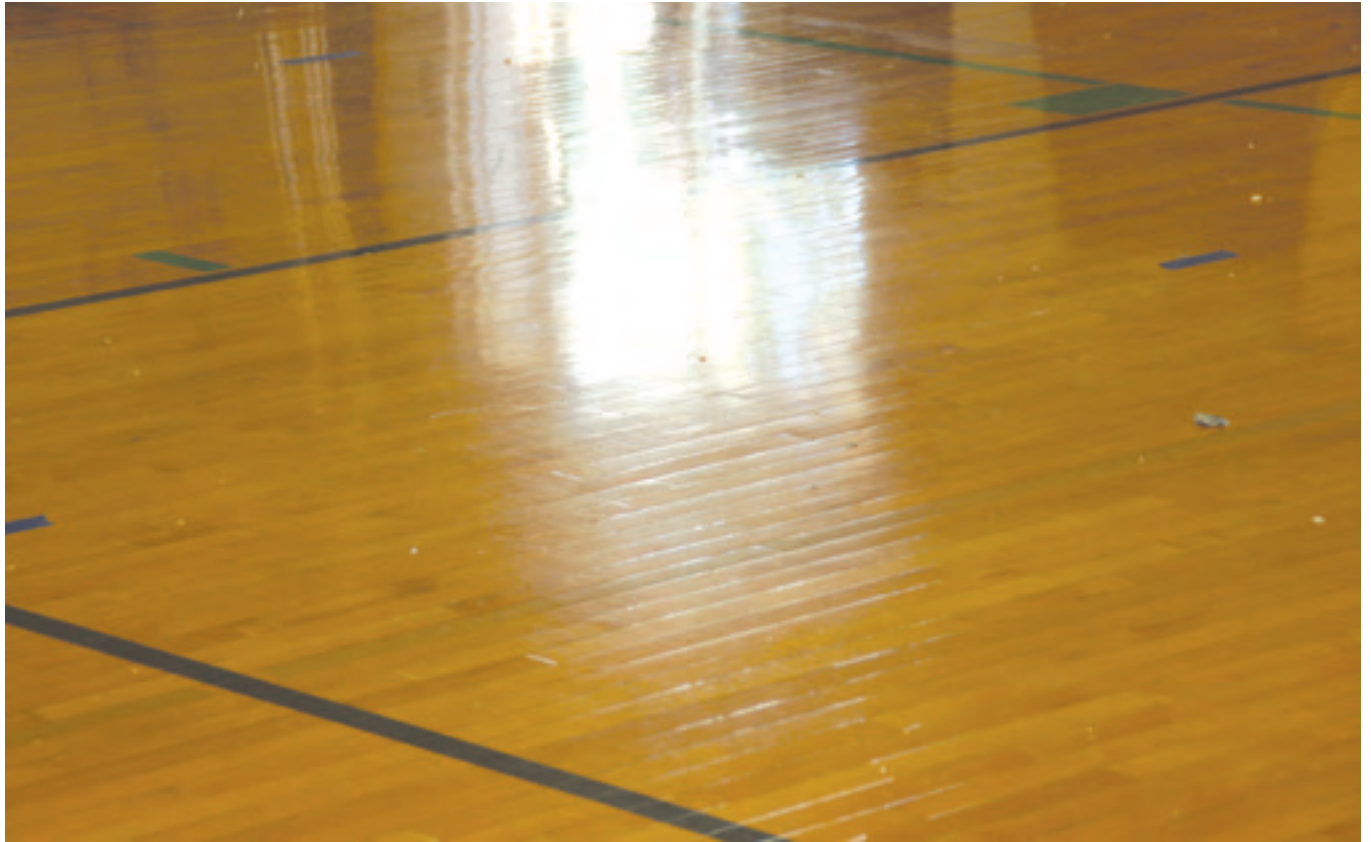
After restoration, the surface of the boards, as well as the floor as a whole, were flat and ready to use. The floor's moisture content was restored to normal levels in just five days. Other methods used elsewhere in the past, such as tenting, would be expected to take two to three times longer—still a considerably faster and more cost-effective choice than replacement.
